An In-Situ Photometric and Energy Analysis of a Sulfur Lamp Lighting System

Doug Crawford, Carl Gould, Michael Packer, Francis Rubinstein, and Michael Siminovitch

Lighting Research Group
Environmental Energy Technologies Division
Ernest Orlando Lawrence Berkeley National Laboratory
University of California
1 Cyclotron Road
Berkeley, California 94720

June 1995

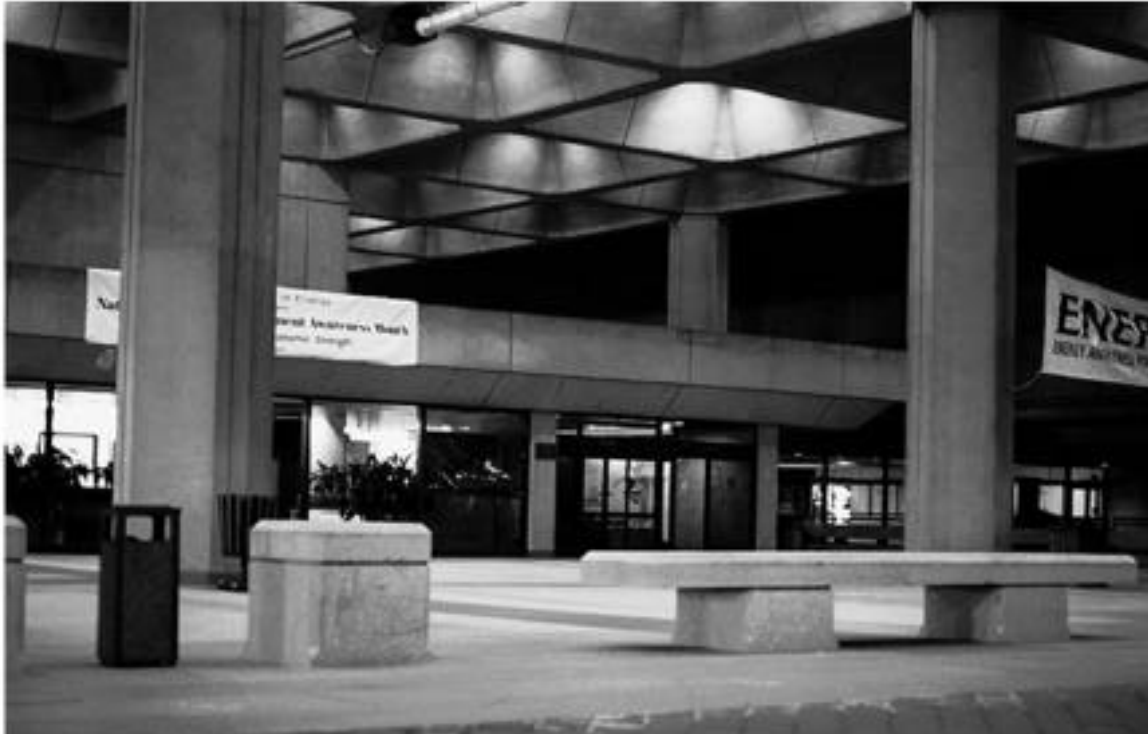
Figure 1. Forrestal Plaza, U.S. Department of Energy

The exterior plaza of the Forrestal building is predominantly a pedestrian walkway with a bisecting roadway. In the test area, the 10.3 m (34 ft.) ceiling of the plaza houses 280 175 W mercury HID fixtures. Four fixtures are recessed within the corners of each of the square concrete coffers covering the ceiling (Figure 1). Forrestal facility records indicate that approximately ten years ago, the existing 175 W mercury HID lamps were placed in fixtures intended for the PAR type reflector lamps of a previous system. Several years later, the Forrestal plaza floor was retrofitted with thin concrete pavers on top of a thin, waterproof membrane. The fragility, and subsequent loading limitations, of the pavers and membrane makes lamp and fixture maintenance a labor intensive process. Consequently, minimal lamp maintenance has occurred, resulting in low illumination levels on the plaza floor.

The new sulfur lamp/light guide system, installed at the site, consists of two 5,900 W, microwave driven sulfur lamps¹ optically coupled to each end of a single 73 m (240 ft.) prismatic film lined light guide.² The light guide is positioned along the long central axis of the plaza and is suspended just below the ceiling girders.
